## AORANGI HOUSE – WELLINGTON’S RECYCLED BUILDING

#### **INDUSTRY PAPER** (Case Study)

This paper examines the refurbishment of Aorangi House, a 12 storey office building in central Wellington. The author was the Project Architect on this refurbishment.

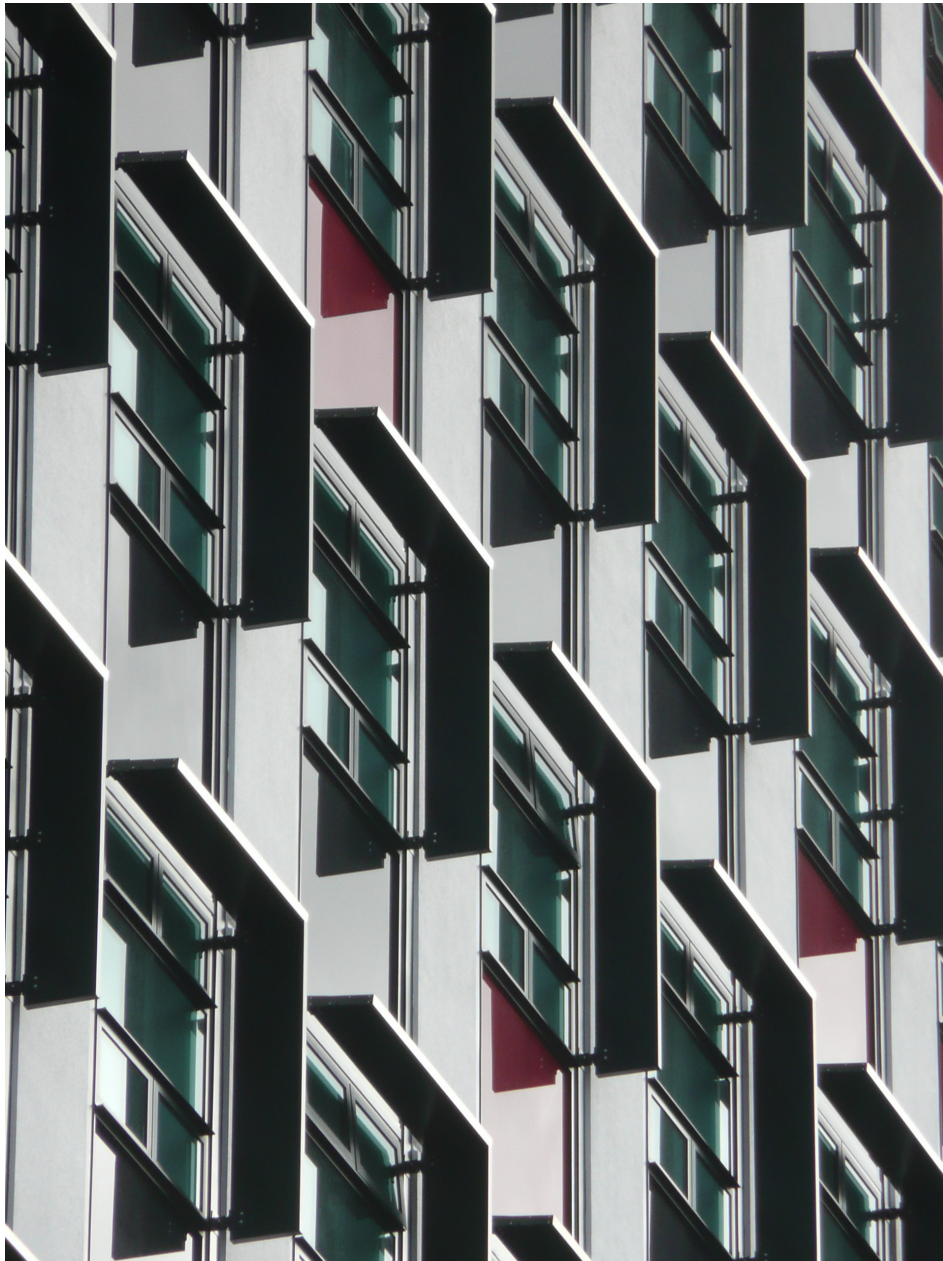
**Figure 1** – External façade shading detail, East façade. Photograph: Guy Marriage

facades were much more interesting. In order to capture a maximum of morning and midday sun shading to east and west, an inverted L shape was devised on Beca's solar shading team advice, to gain the maximum effect. Internally, these sun shades are barely noticeable, and yet the effect they have on the internal solar gain is considerable. They have however had a very significant visual effect on the building, turning what was a very flat façade into one that is visually a lot more dynamic.
